# THE EARTHQUAKE AND TSUNAMI OF NOVEMBER 21, 2004 AT LES SAINTES, GUADELOUPE, LESSER ANTILLES

A strong earthquake ( $m_b = 6.3$ ;  $M_s = 6.1$ ;  $M_w = 6.3$ ) occurred on 21 November 2004 in the Dominica Passage separating Guadeloupe and Dominica, in the Lesser Antilles, and generated a weak tsunami with maximum amplitudes of +70 and -80 cm on neighbouring islands. We conducted field surveys on the islands of “Les Saintes”, in the immediate vicinity of the epicenter on November 27, 2004 and February 12, 2005, and report here on the resulting dataset.

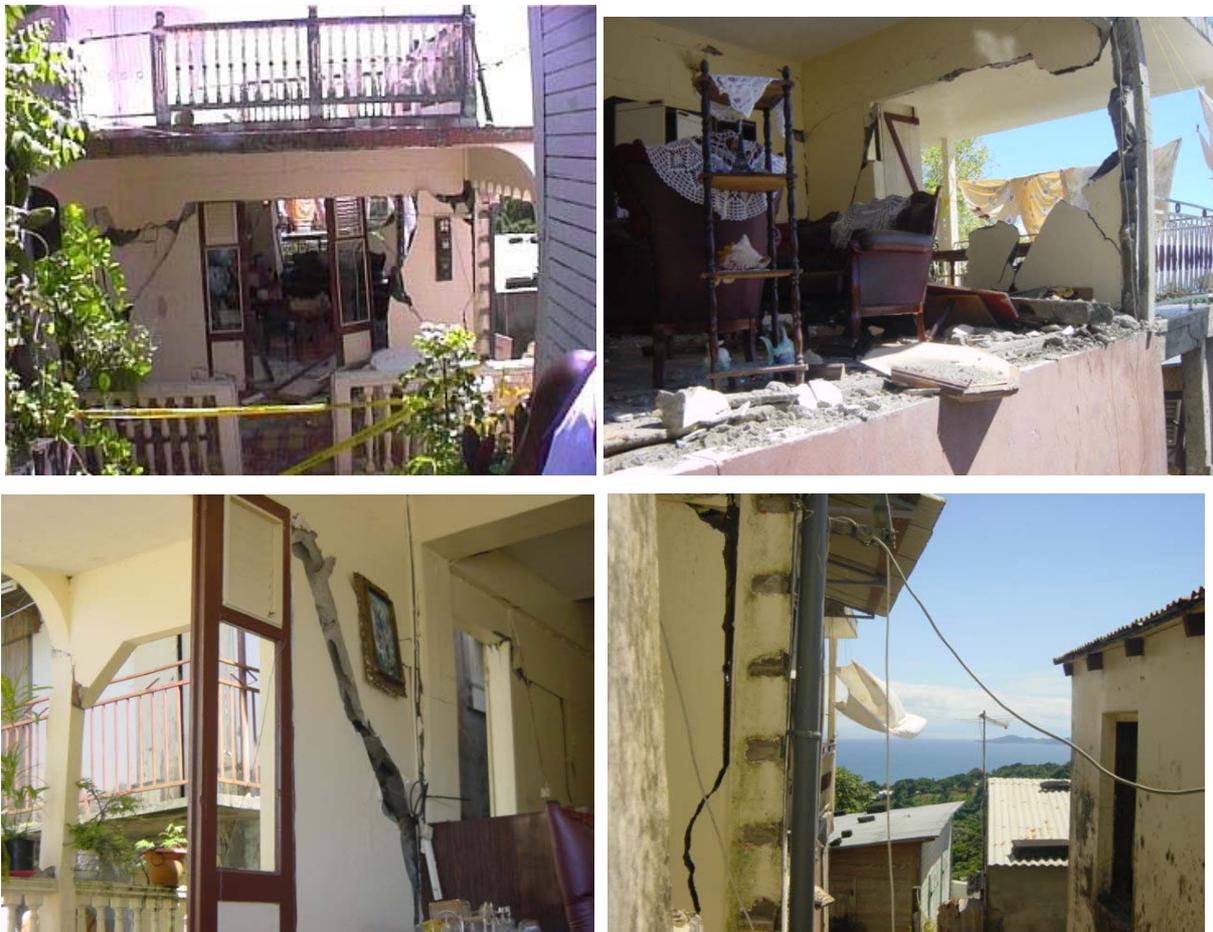
**Figure 2.** Houses at Trois-Rivières, Guadeloupe damaged during the earthquake (Photographs by N. Zahibo and A. Yalçın). In the last photograph, the islands of Les Saintes, where the earthquake was destructive, can be seen in the background.

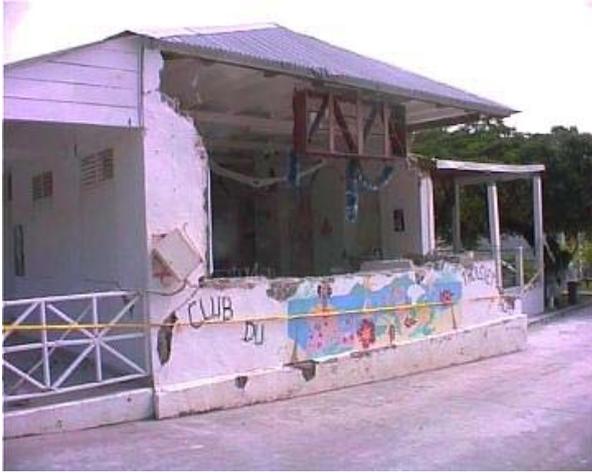
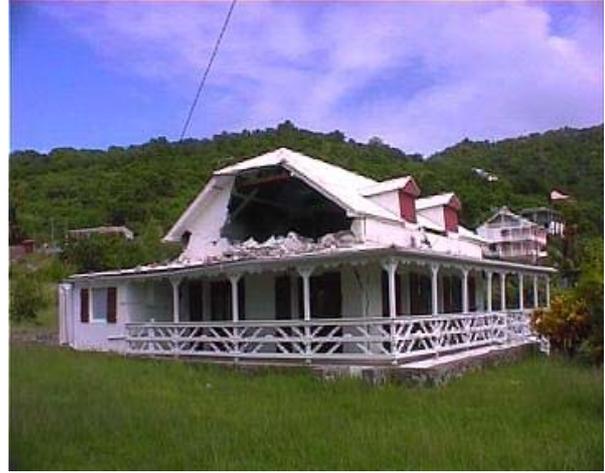
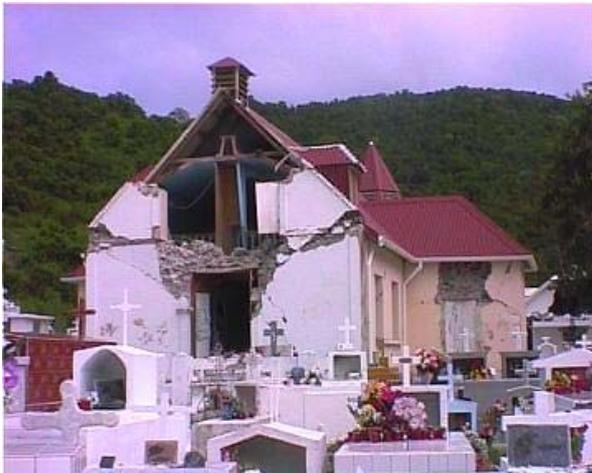
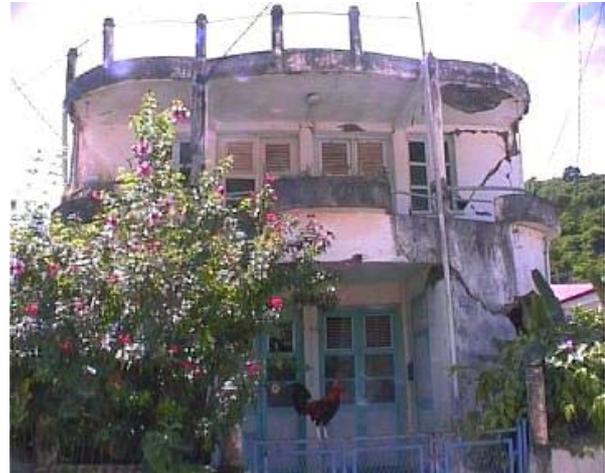
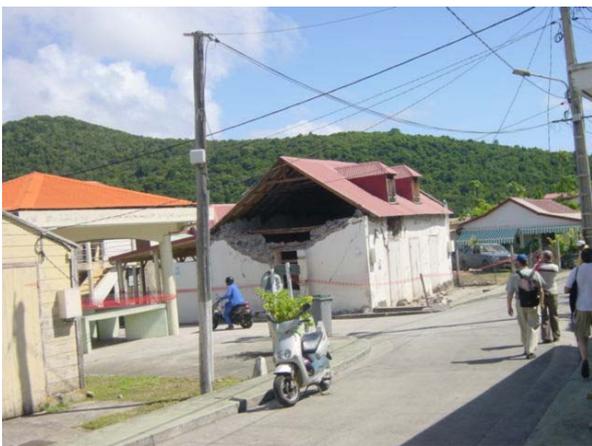
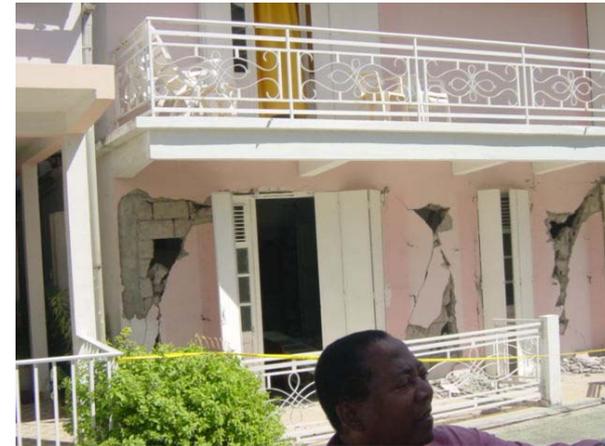
**Figure 3.** Houses damaged by the earthquake at Petites-Anses, Terre-de-Bas Island (Les Saintes, Guadeloupe; Photographs by N. Zahibo and A. Yalçiner).

**Village of Trois-Rivières.** One person (a 5-year old girl) was killed, at least two other injured, and several houses destroyed or damaged in this village (Figure 3). In the port (15°58'084N, 61°38'695W), one fisherman reported that his boat dropped down about 50 cm during the earthquake and then rose back; he was afraid his boat could hit the sea bottom and tip over. A panorama of this port is shown in Figure 8.

**Village of Petites Anses.** At least eight houses were destroyed and twenty-five damaged in this village (Figure 3). At the small bay “Anse à Dos” (see Figure 10 for location), a fisherman said that water receded a distance of 2 to 3 m just after the earthquake, and then rose back to normal level.

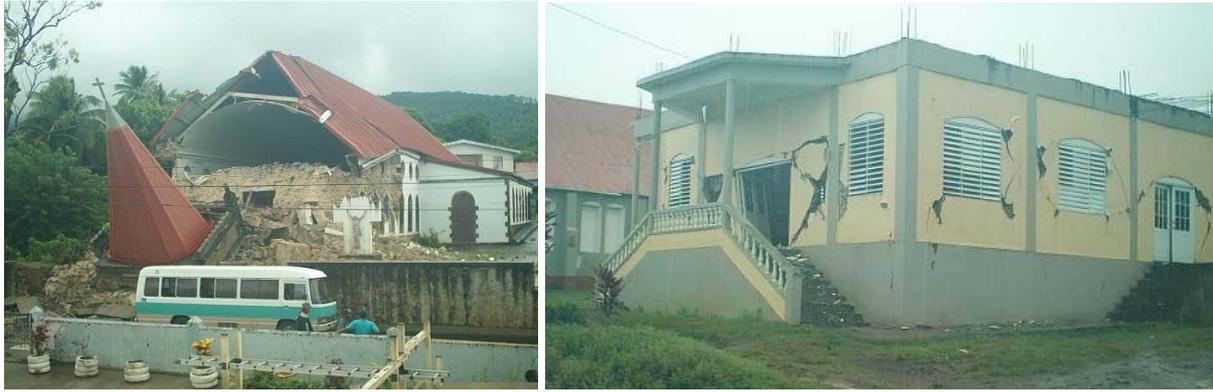
**Figure 4.** Roman Catholic and Methodist Churches at Portsmouth, Dominica damaged during the earthquake (Wayne Abraham, <http://dominicapsn.freeyellow.com/gallery.html>).

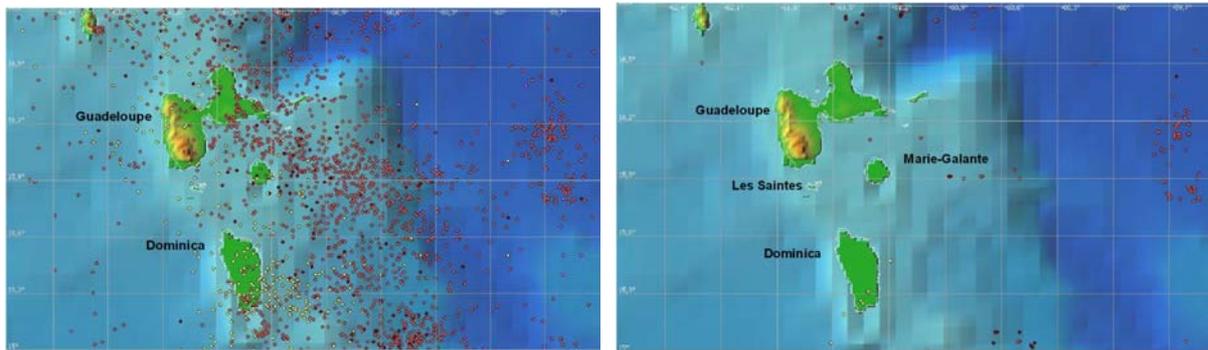
**Figure 5.** Seismicity of Guadeloupe and Dominica (left), and distribution of earthquakes with magnitudes greater than 5.0 (HTDB/ATL, 2002). Note that, before the November 2004 earthquake, the latter were concentrated at the trench.

As documented on Figure 5 (HTDB/ATL, 2002), the seismicity of the area is generally high, but most earthquakes remain weak, with only eight events (listed in Table 1) exceeding a magnitude of 6.

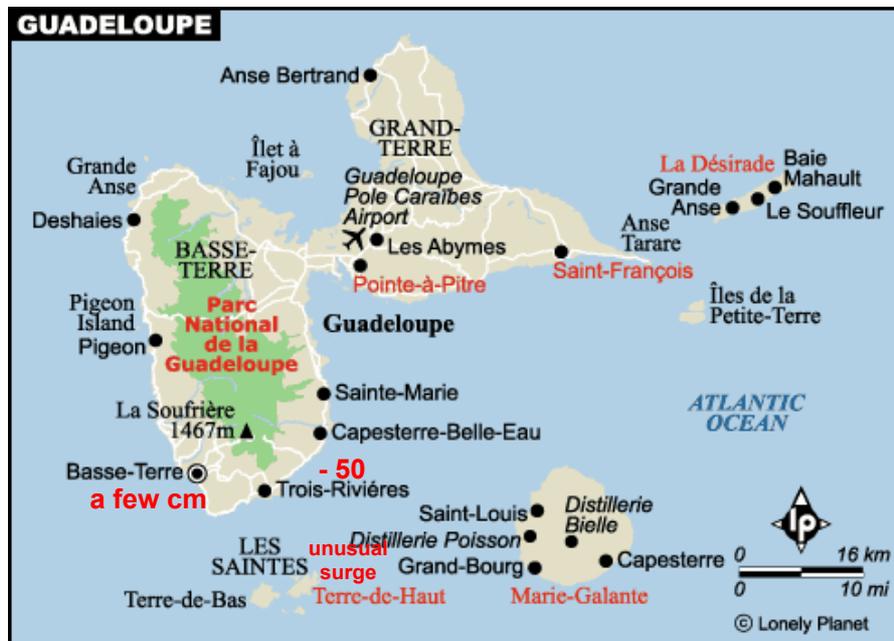
Figure 7. Map of the main island of Guadeloupe.

**Basse-Terre (part of the main Island of Guadeloupe)** (see Figure 7 for location of all points, and tsunami heights in cm).

**Island of Terre-de-Haut, Les Saintes.** As one witness reported, an “unusual” surge was observed in “Baie du Marigot” (see Figure 7 for location), but there were no reports of earthquake damage from that island.

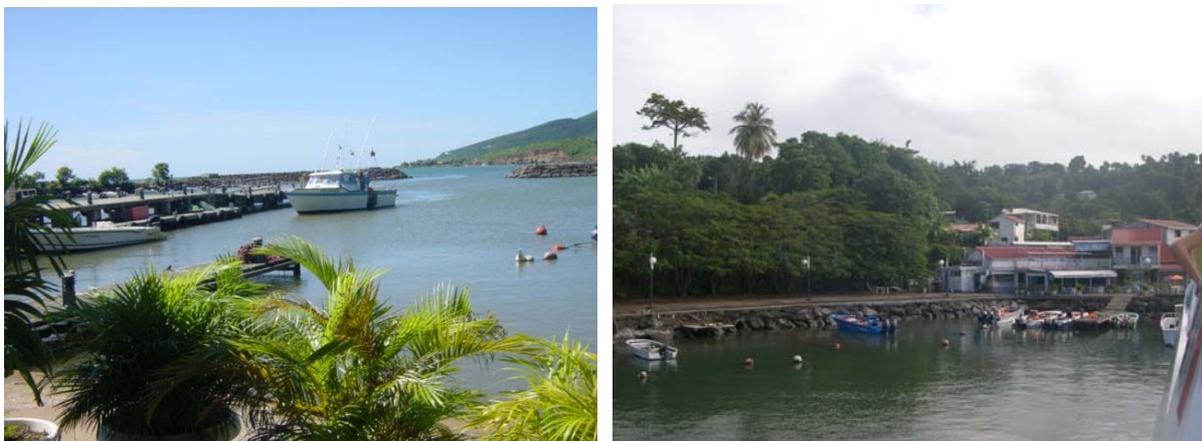
Figure 8. Panorama of the port of Trois-Rivières, where the reported tsunami depression was about 50 cm

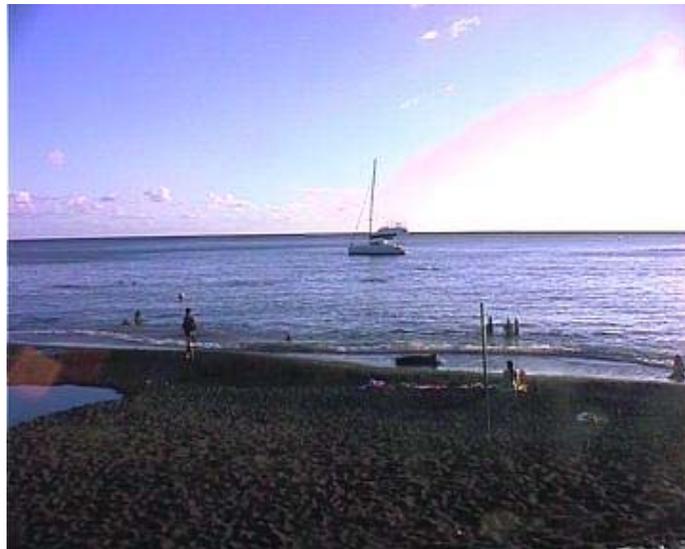
**Figure 9.** Panorama of the Marina de Rivière Sens, where the tsunami was reported as a weak depression.

**Marina de Rivière Sens (city of Basse-Terre).** One witness informed us that the water dropped down a few cm and then rose back during the earthquake. A panorama of the beach where the tsunami was recorded is shown in Figure 9.

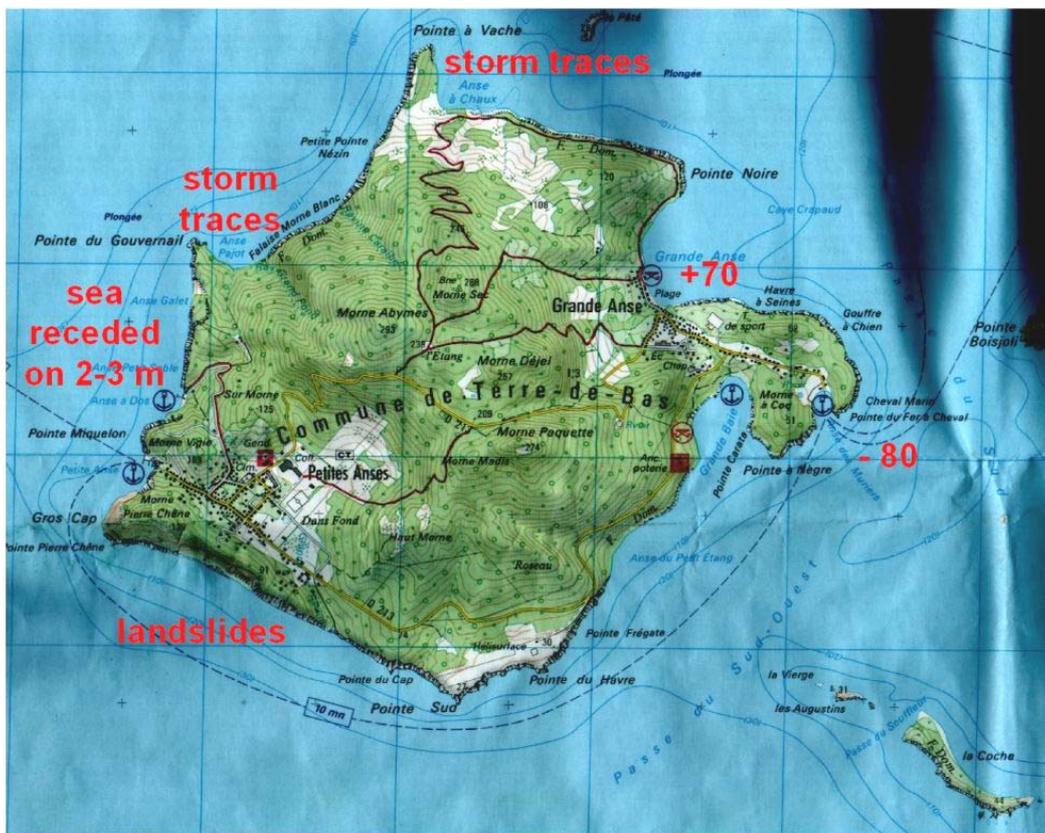
**Figure 10.** Map of Terre-de-Bas Island.

**Island of Terre-de-Bas, Les Saintes** (see Figure 10 for location of points and wave amplitudes).

**Bay “Anse Pajot”** (see Figure 10 for location). A watermark at a height of about 50 cm was found on February 12, 2005 during the second survey around Terre-de-Bas (Figure 13). Early observation of these traces by local inhabitants suggests their deposition by storm surges, even though no major precipitation occurred since the day of the tsunami.

**Bay “Anse à Chaux”** (see Figure 10 for location). Large watermarks are also visible on the beach in this bay (Figure 14). Here again, storm surges are preferred as their origin. According to reports from fishermen, storm waves approach mainly from the North, and this explains why such watermarks would be found only in those two bays, favorably open to the prevailing winds.

The southwest part of the coast, between capes “**Pointe-Sud**” and “**Gros Cap**” (see Figure 10 for location), facing directly towards the earthquake epicenter, features many fresh rockslides and landslides (Figure 15), identified by local residents as triggered during the earthquake. There, the coast is locally very steep (with cliffs as high as 30 m), and the identification of potential tsunami deposits is thus very difficult. On the South-east coast, from “Grande Baie” to “Pointe Frégate”, the beach is lower (Figure 16), but we could not find definitive tsunami traces.

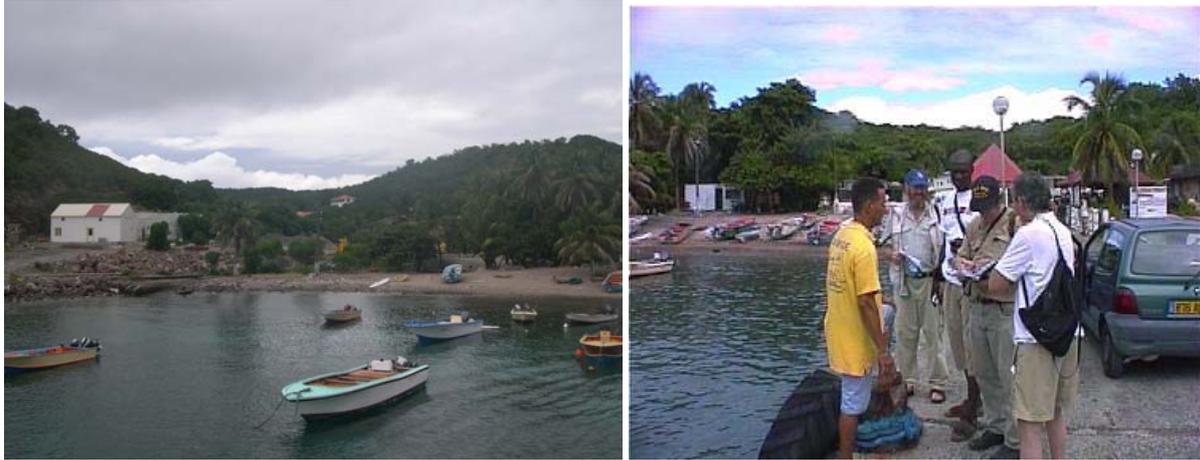
**Figure 11.** Panorama of the bay and interview of the tsunami witness in Bay “Anse des Muriers”.

**Village of Grande Anse, Bay “Anse des Muriers”** ( $15^{\circ}51'260\text{N}$ ,  $61^{\circ}36'968\text{W}$ ). A ship captain reported that 3 minutes after the earthquake, the sea receded 5 m (and dropped 80 cm) and rose back to its still level, over perhaps 1 minute. Photographs of this bay are given in Figure 11.

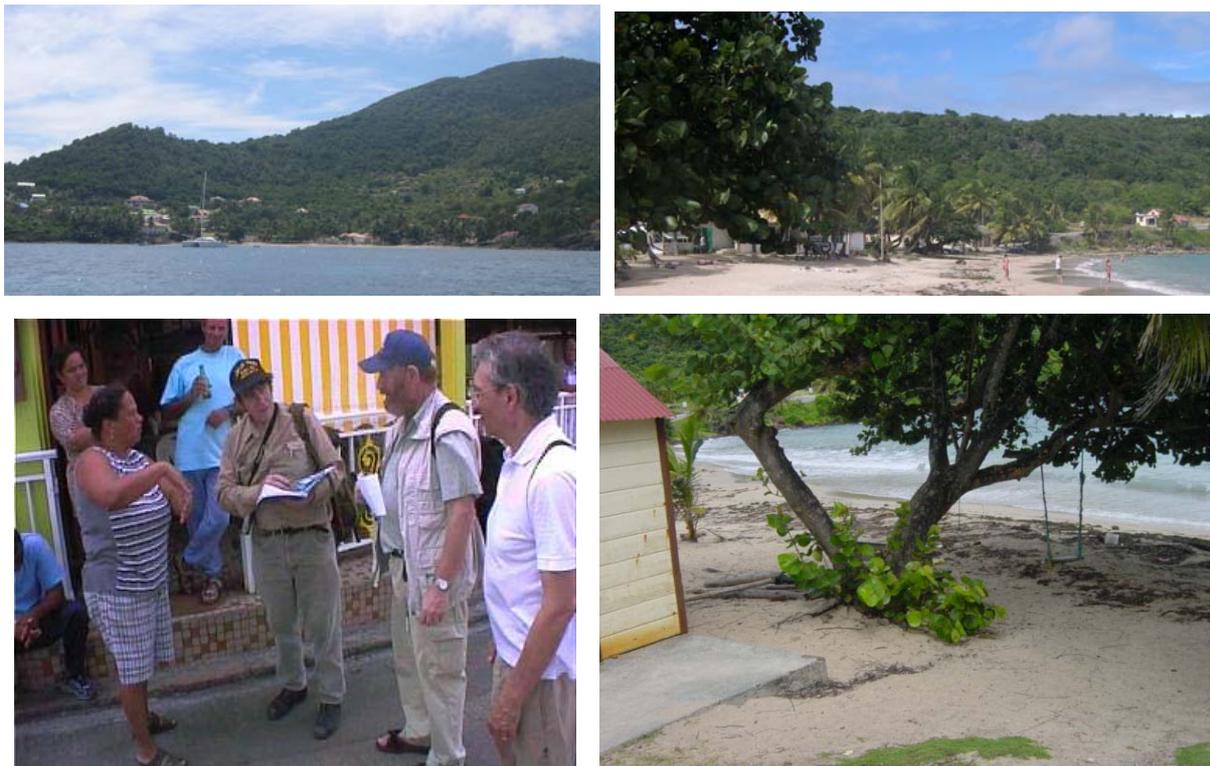
**Figure 12.** Panorama of the bay “Grande Anse”, and interview with restaurant owner (left); the tsunami reached the house on the beach (right).

**Beach of Grande Anse** ( $15^{\circ}51'547\text{N}$ ,  $61^{\circ}37'476\text{W}$ ). A restaurant owner informed us that the tsunami began as an ebbing phase, and then a positive wave reached a house on the beach; we surveyed this run-up as 70 cm (see Figure 12). According to this witness, the wave shape was

like an undular bore, which could have resulted from significant wave dispersion on this locally very gently sloping beach.

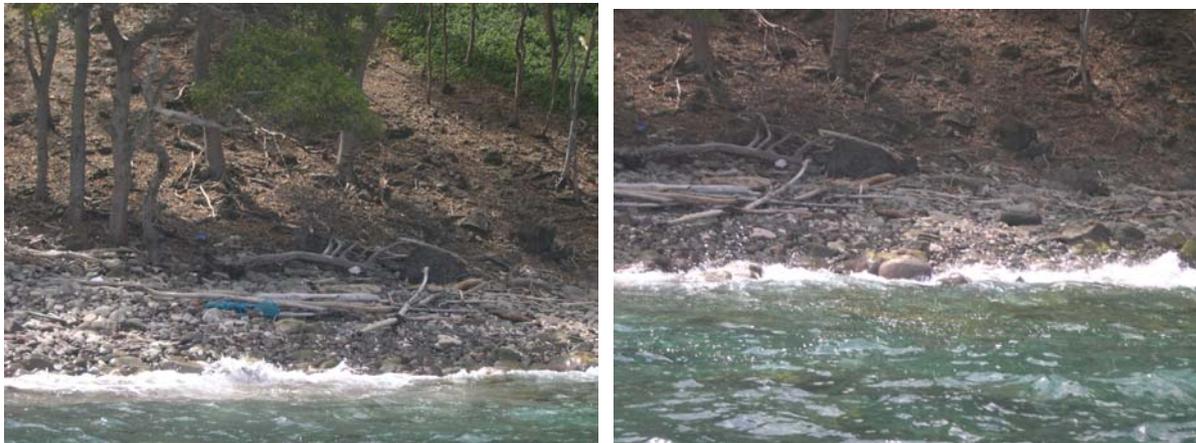
**Figure 13.** Watermarks in the bay “Anse Pajot”.

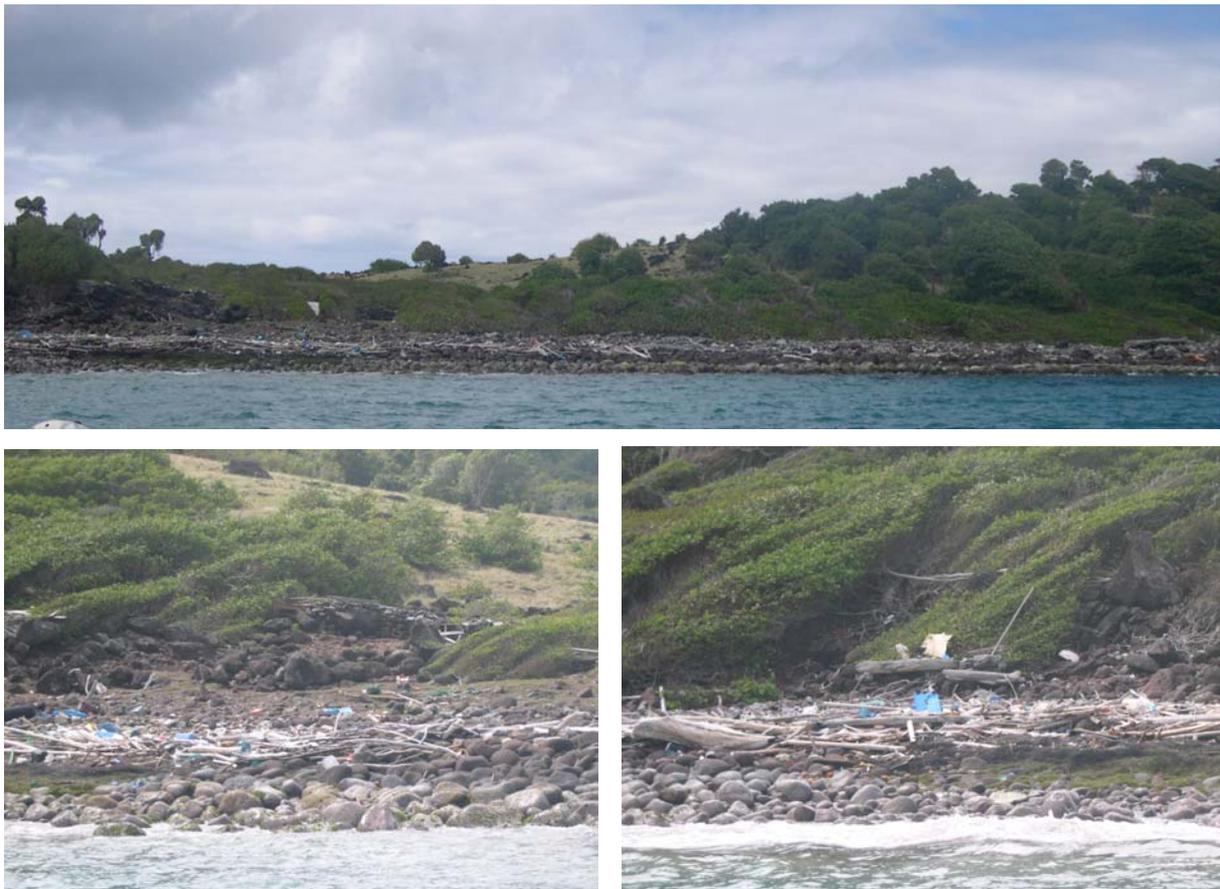
**Figure 14.** Visible traces of the wave runup in the bay “Anse à Chaux”.

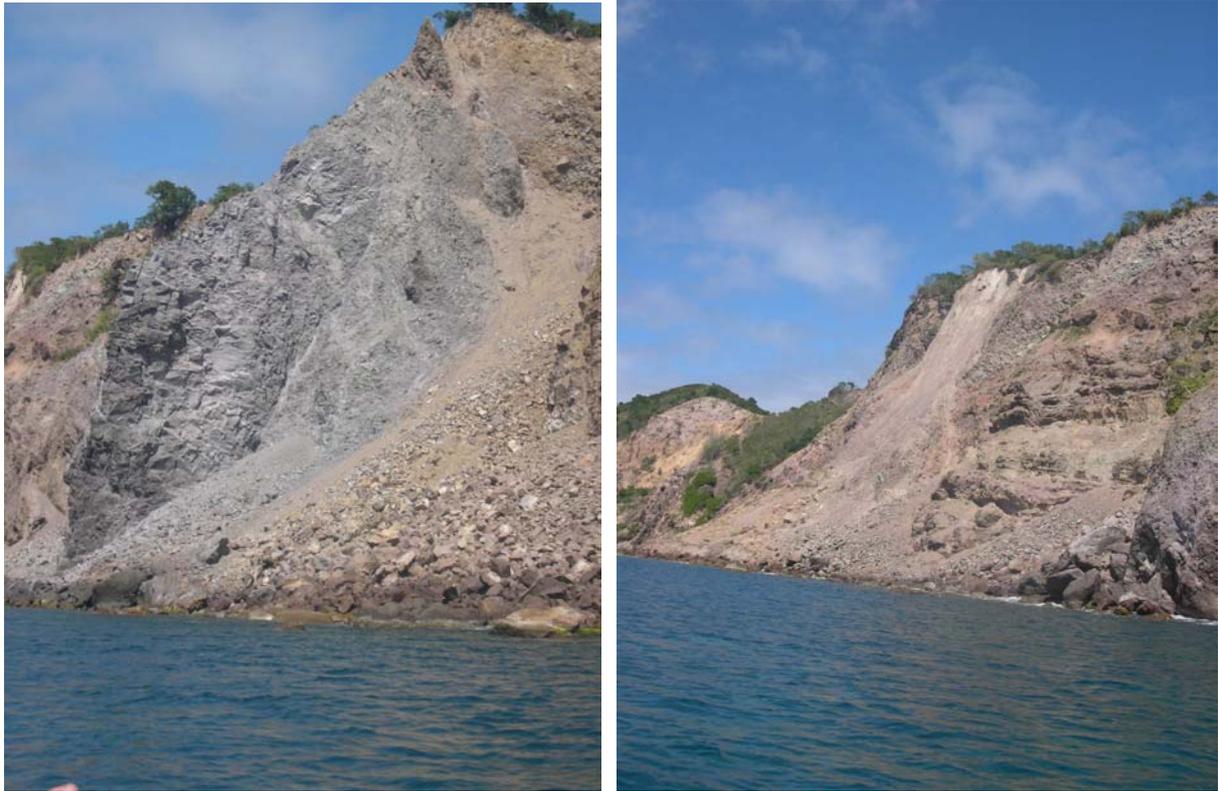
**Figure 15.** Locations of rock- and land-slides on the Southwest coast of Terre-de-Bas.

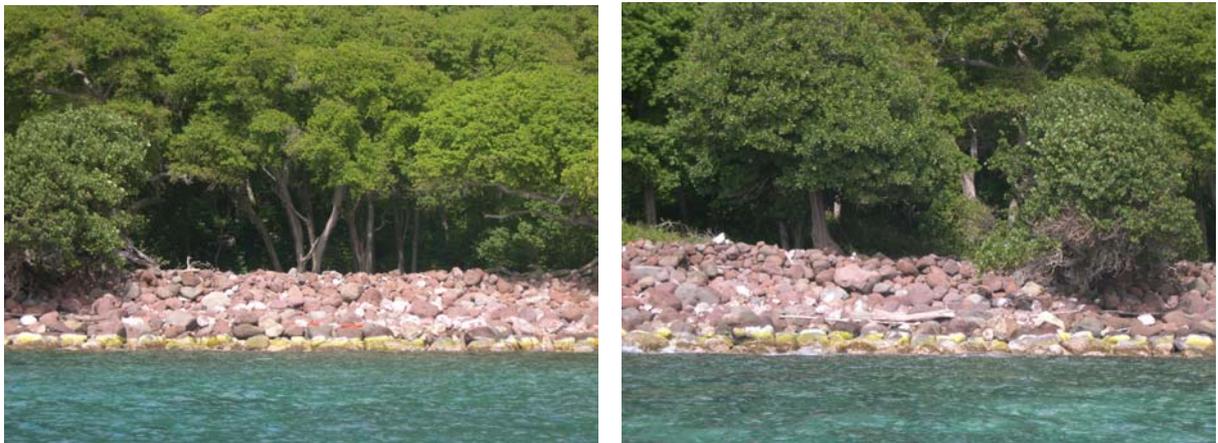
**Figure 16.** Beach on the west part of the bay “Grande Baie”, Terre-de-Bas.
